Chena River Lakes Project  
Fairbanks, Alaska

*Overview of Tanana River monitoring and  
research studies near Fairbanks, Alaska*

OVERVIEW OF TANANA RIVER MONITORING AND  
RESEARCH STUDIES NEAR FAIRBANKS, ALASKA  
(with Appendices)

Prepared by  
U.S. Army Cold Regions Research and Engineering Laboratory  
Hanover, New Hampshire

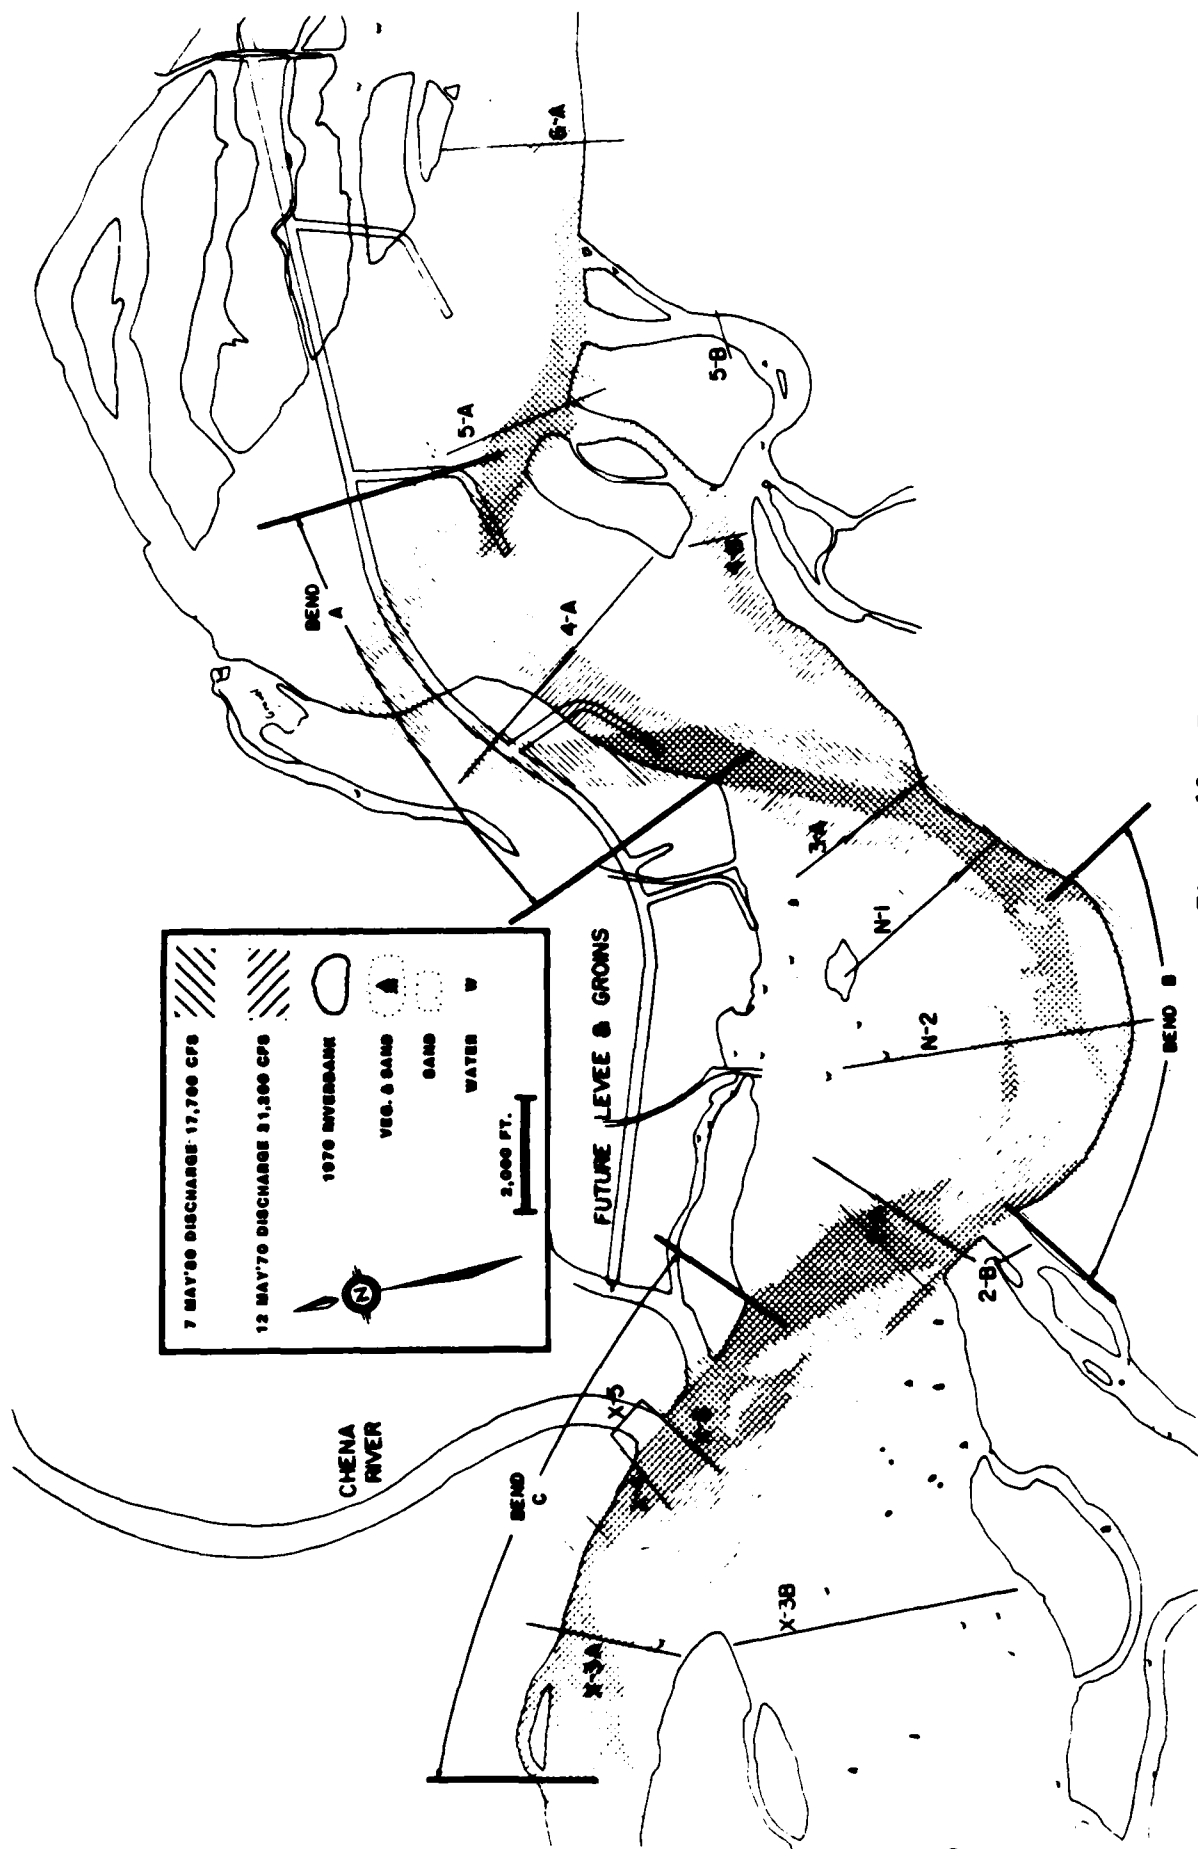
Figure 12. Tanana riverbank erosion and channel migration from 29 May 1981 to 20 October 1981.

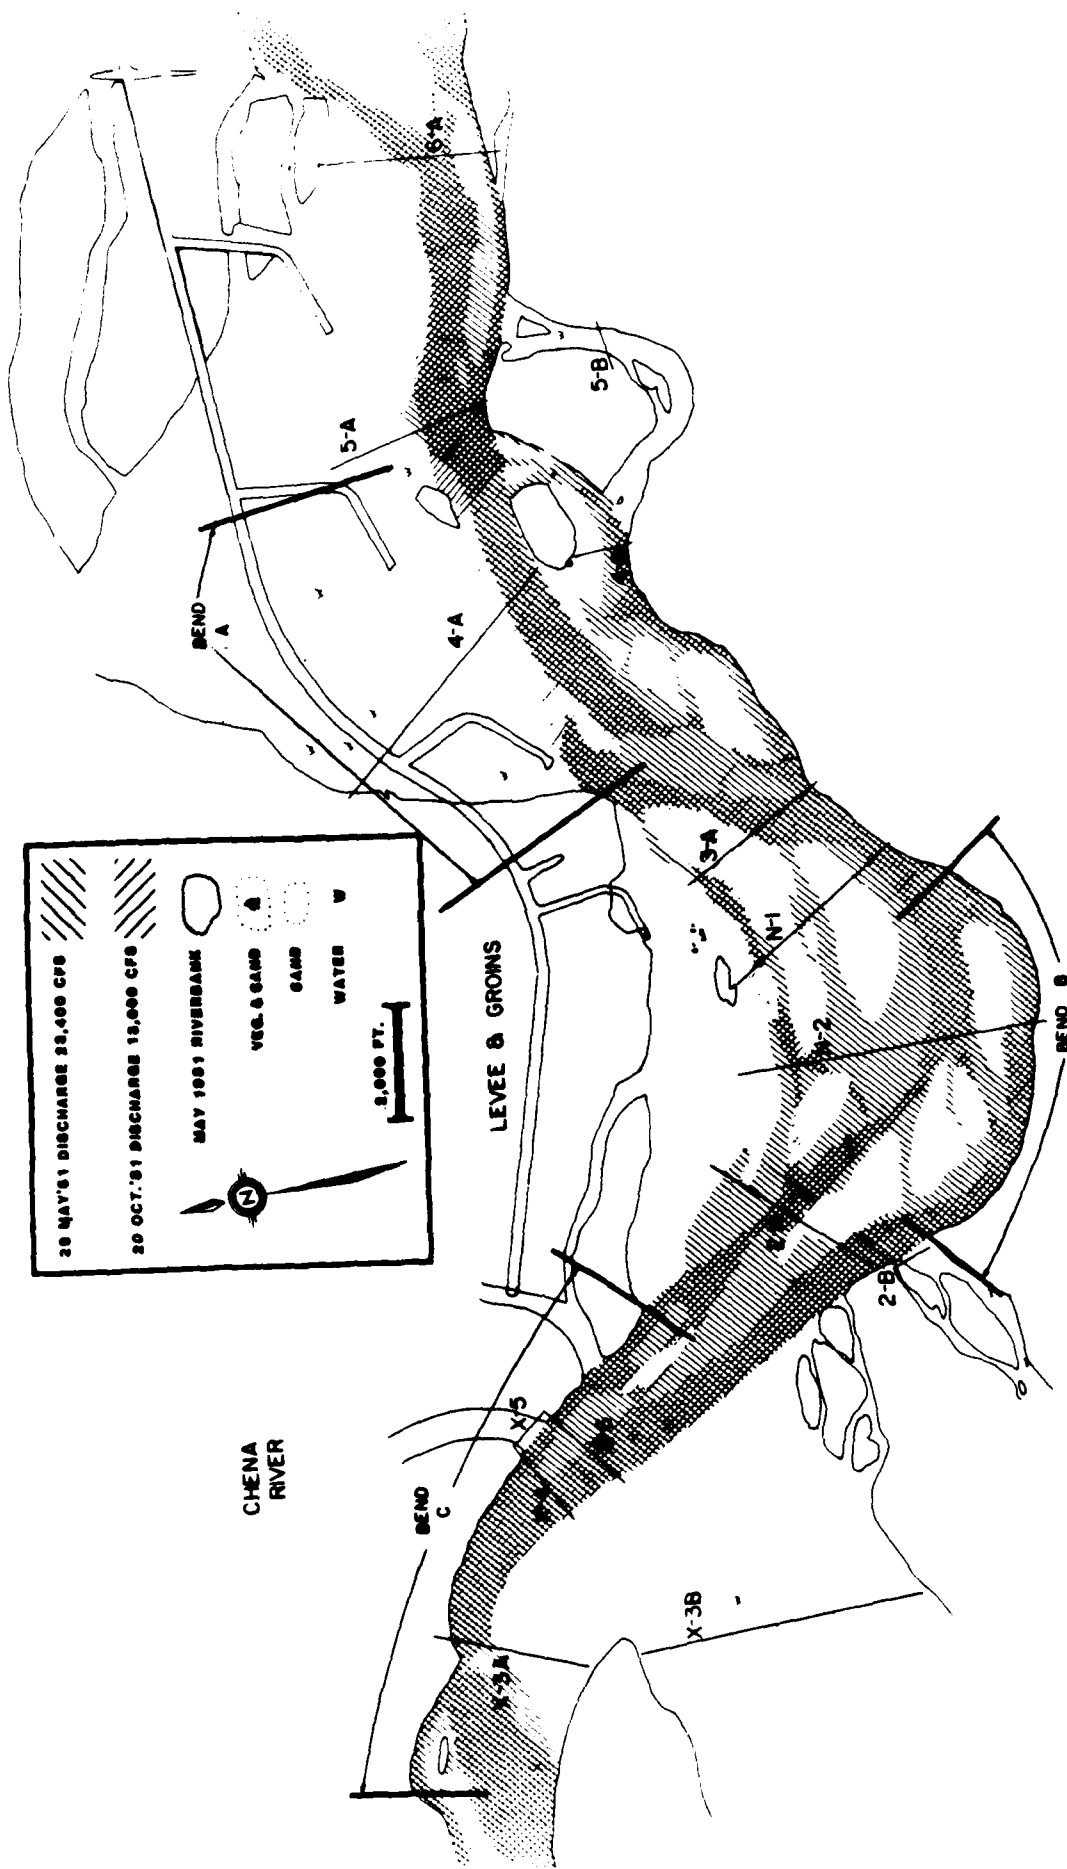
Figure 13. Tanana riverbank erosion and channel migration from 29 May 1981 to 20 October 1981.

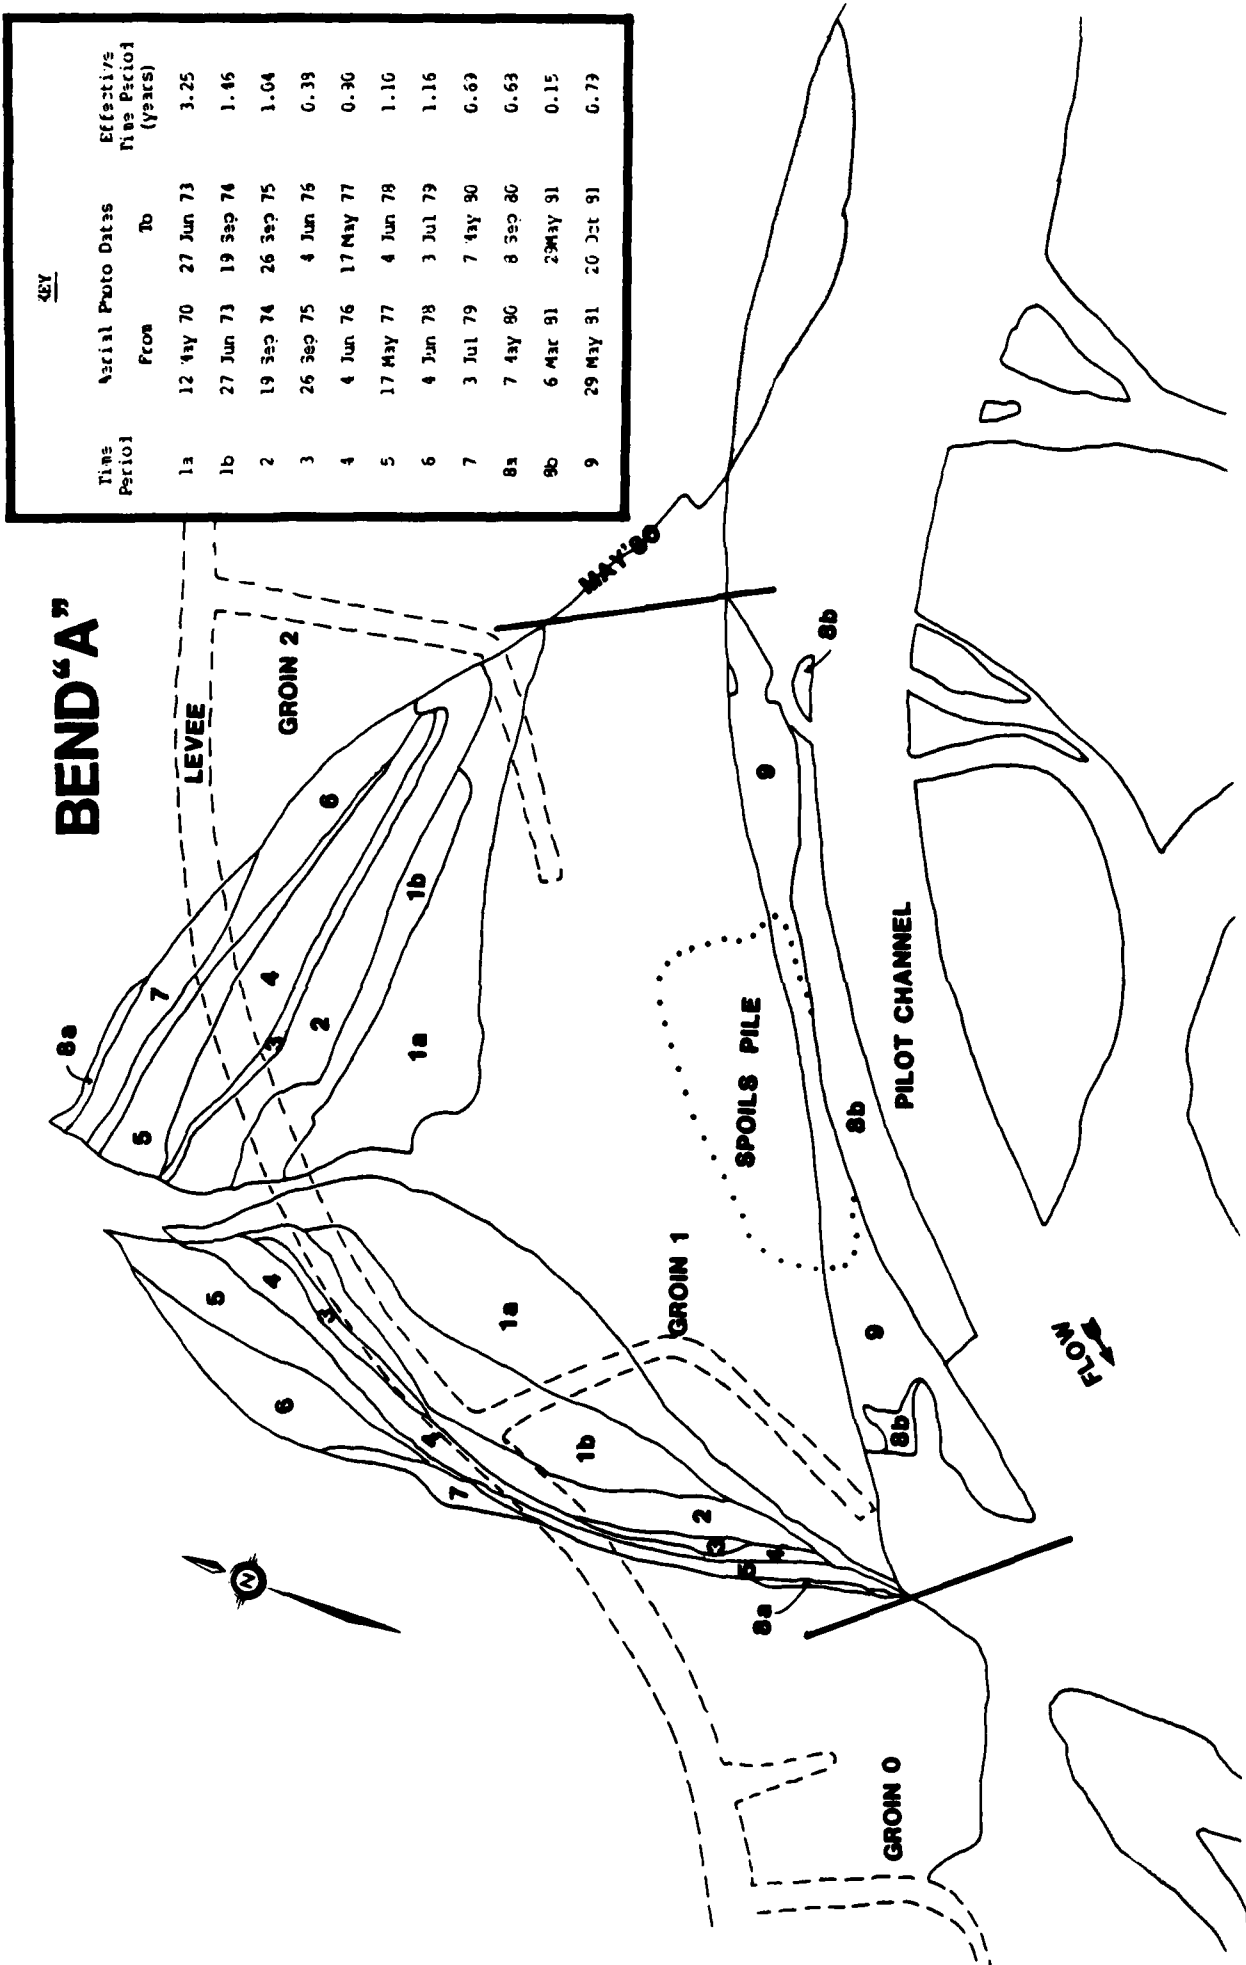
Figure 14. Riverbank erosion detail, Bend A, 12 May 1970 to 20 October 1981.

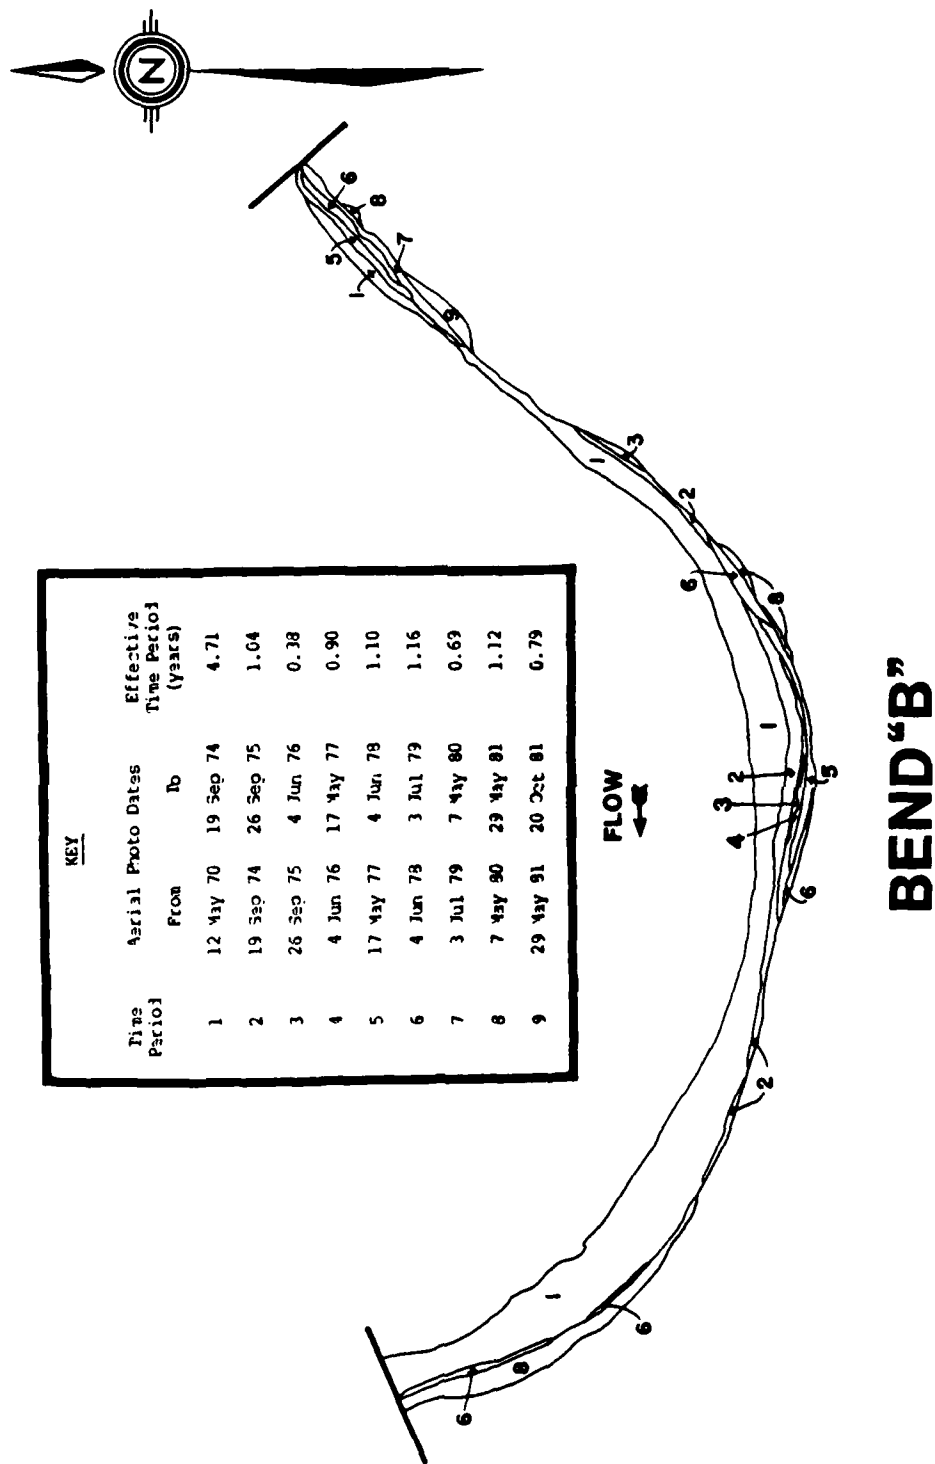
Figure 15. Riverbank erosion detail, Bend B, 12 May 1970 to 20 October 1981.

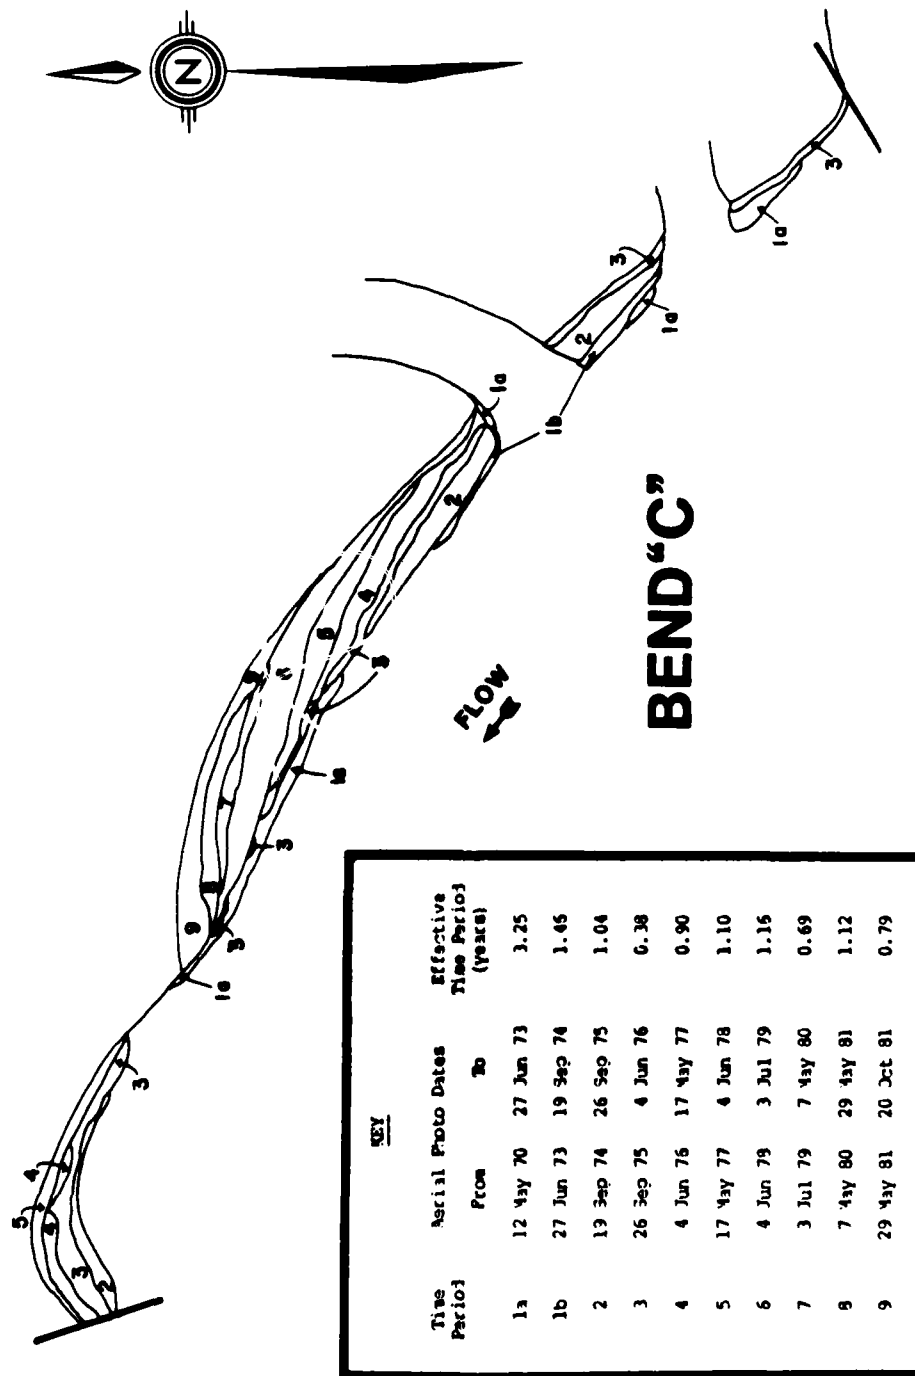
Figure 16. Riverbank erosion detail, Bend C, 12 May 1970 to 20 October 1981.

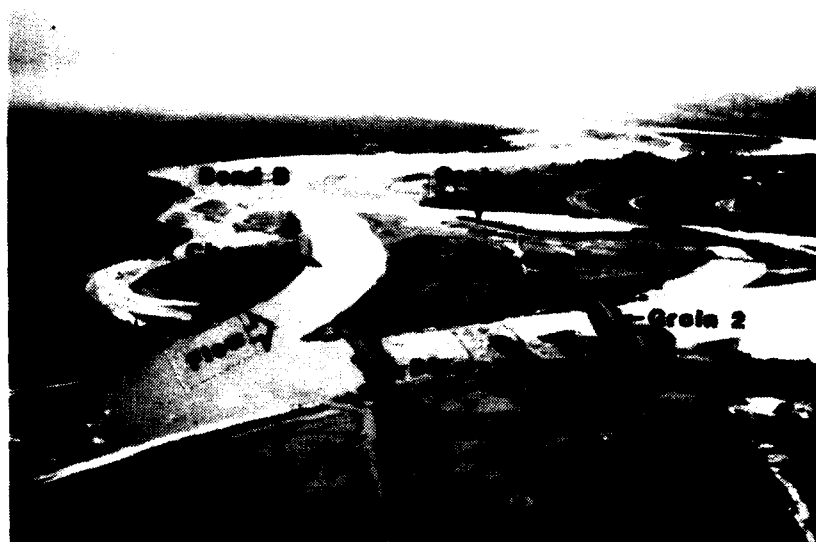
Figure 17. Pilot channel and spoils pile on 1 May 1981.

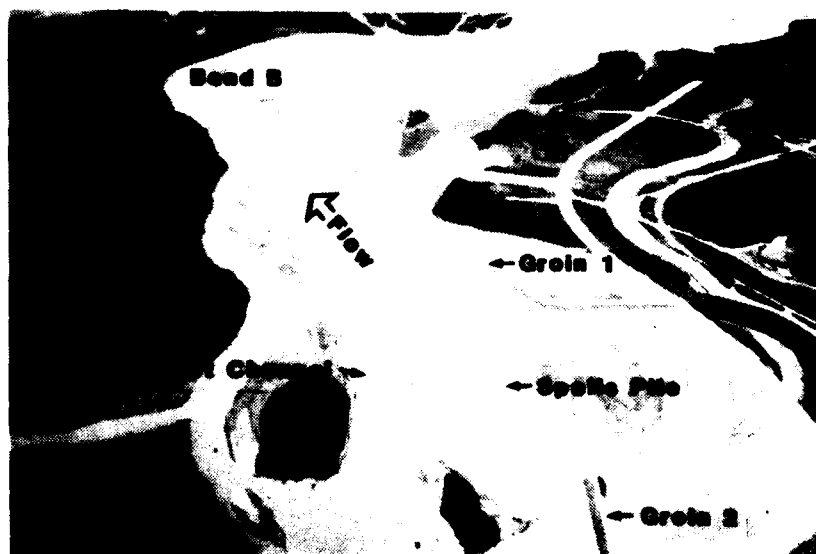
Figure 18. Pilot channel and spoils pile on 6 June 1981.

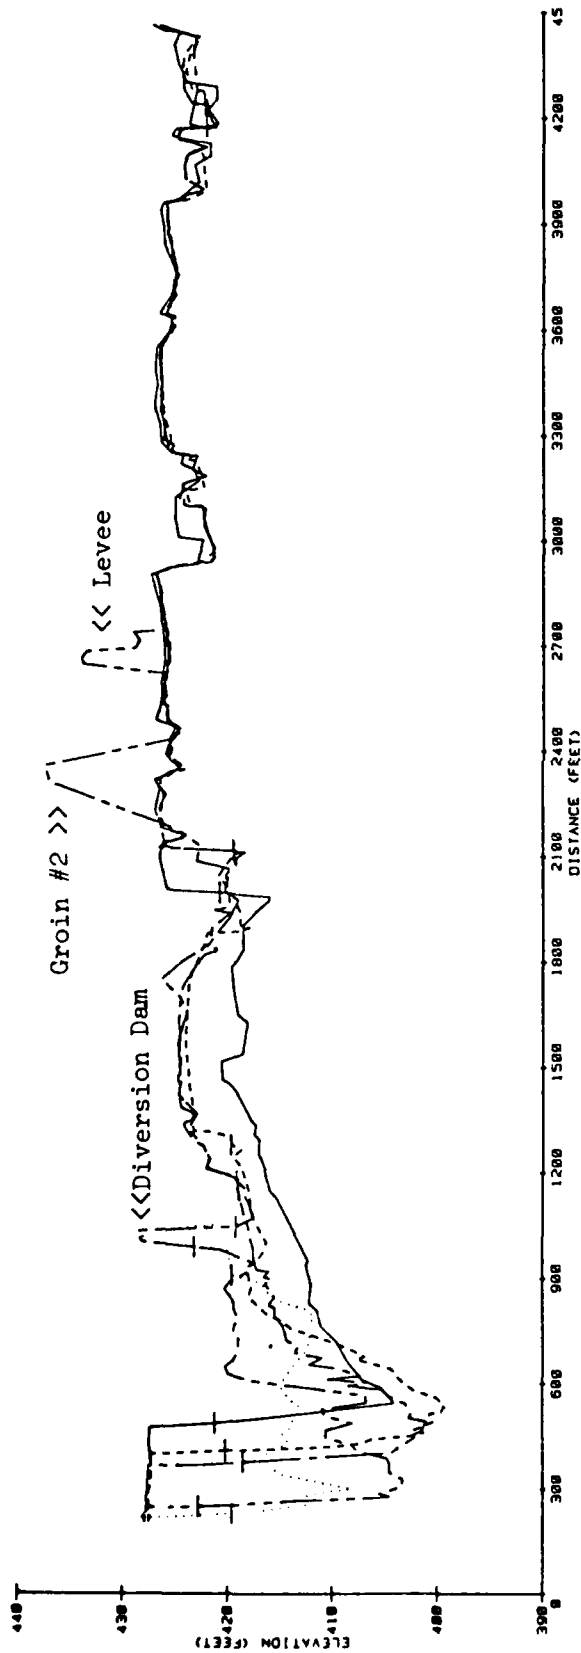
Figure 19. Tanana River cross section 5A, 1977-1981.

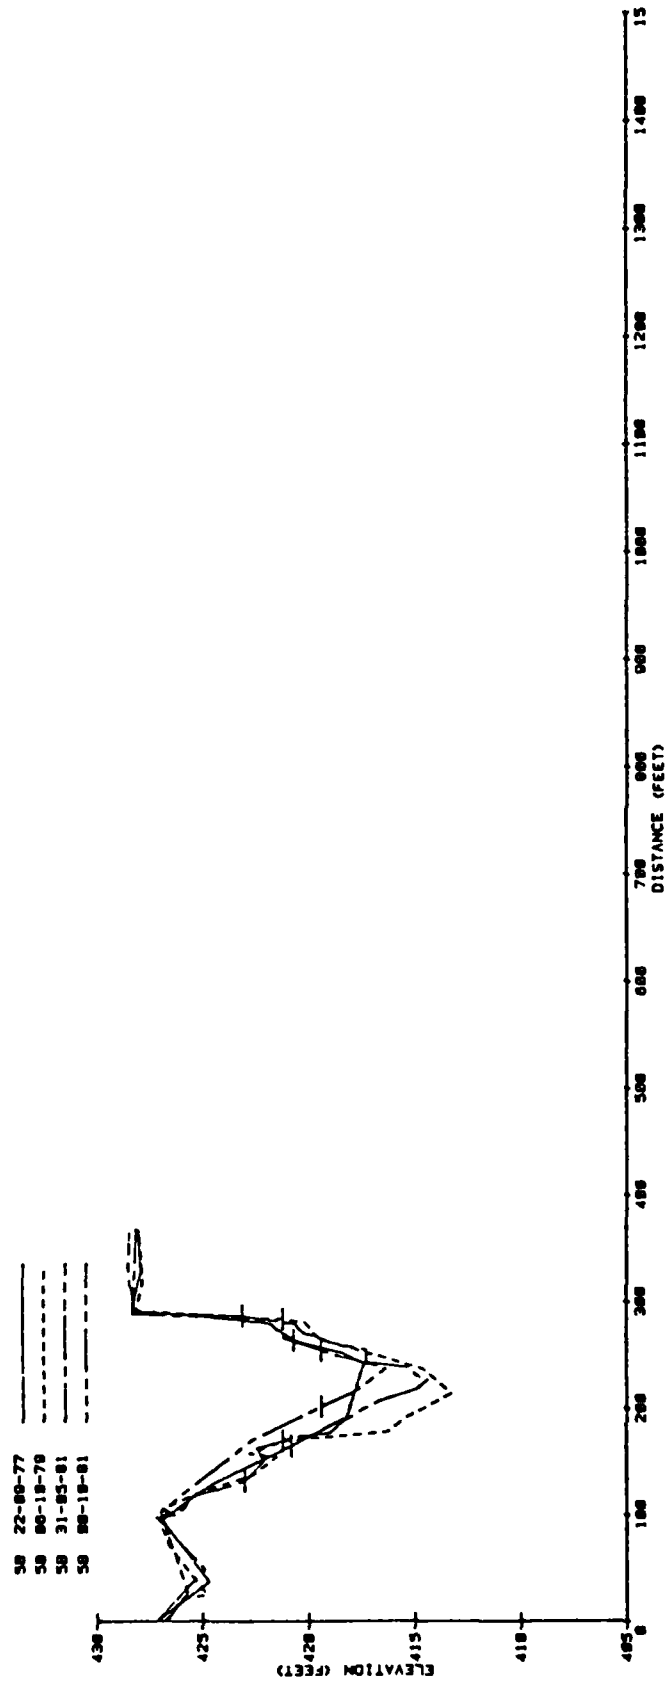
Figure 20. Tanana River cross-section 5B, 1977-1981.

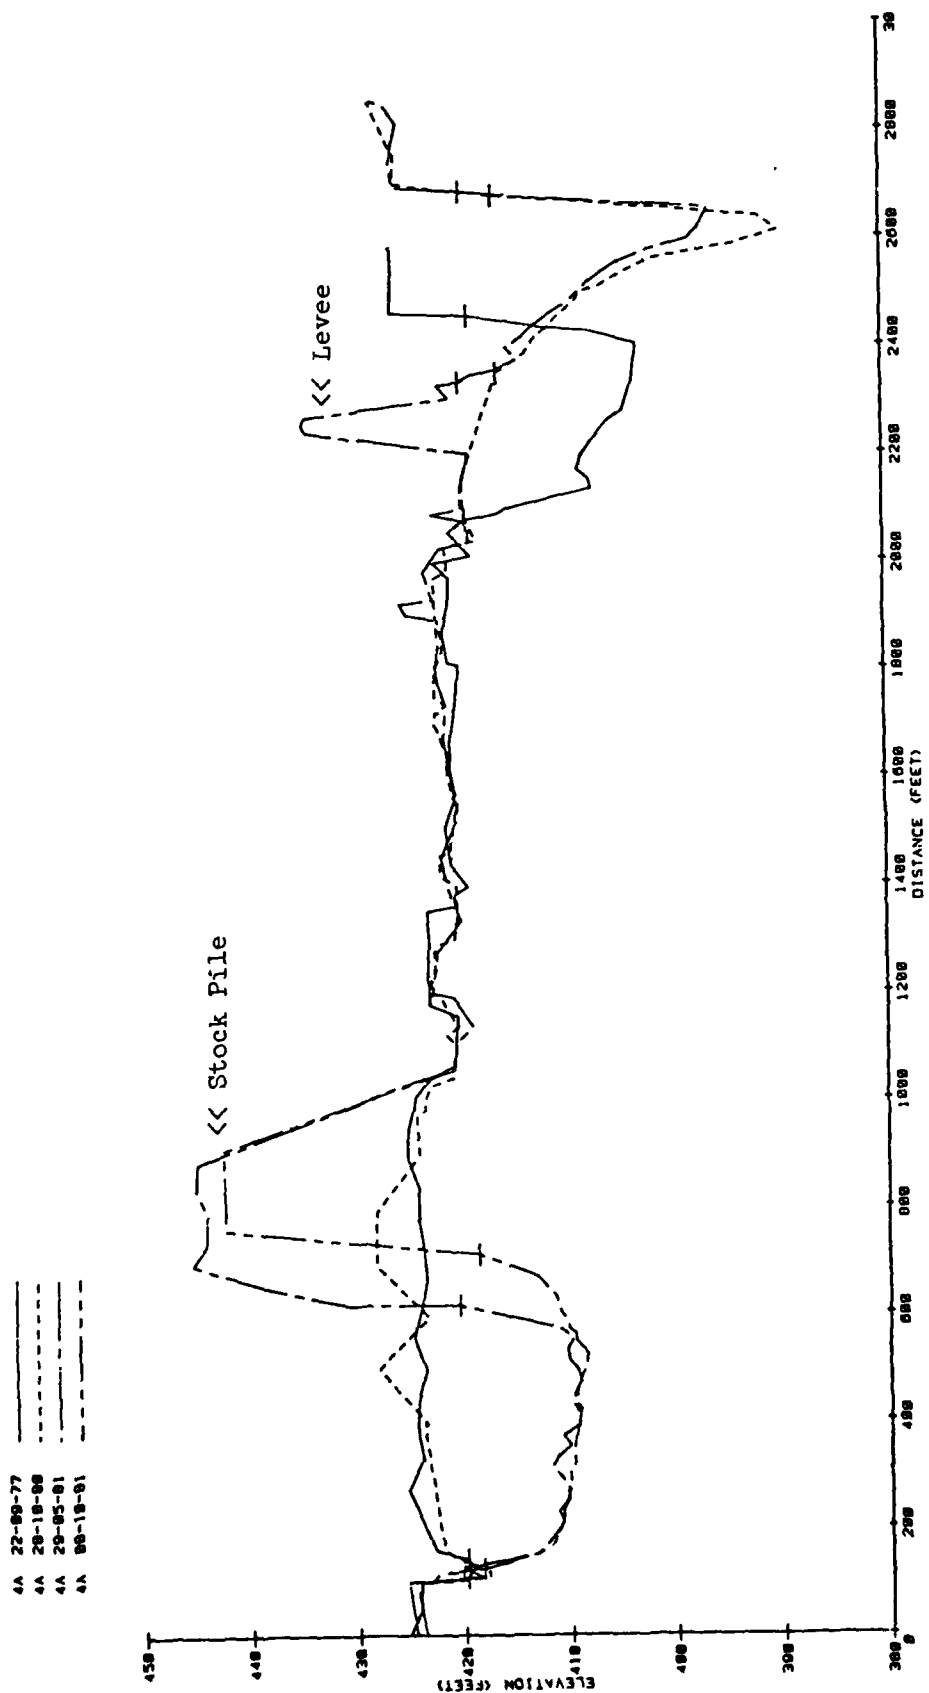
Figure 21. Tanana River cross section 4A, 1977-1981.

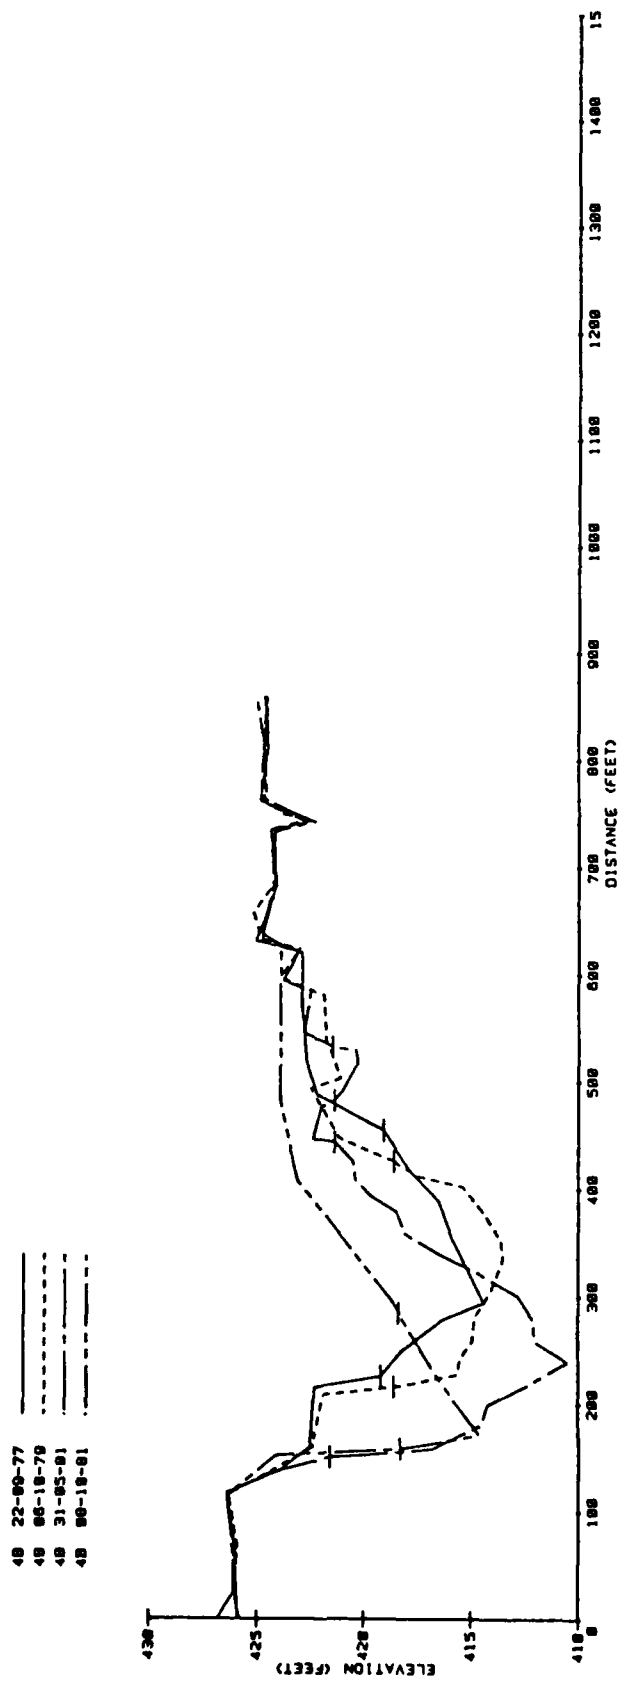
Figure 22. Tanana River cross section 4B, 1977-1981.

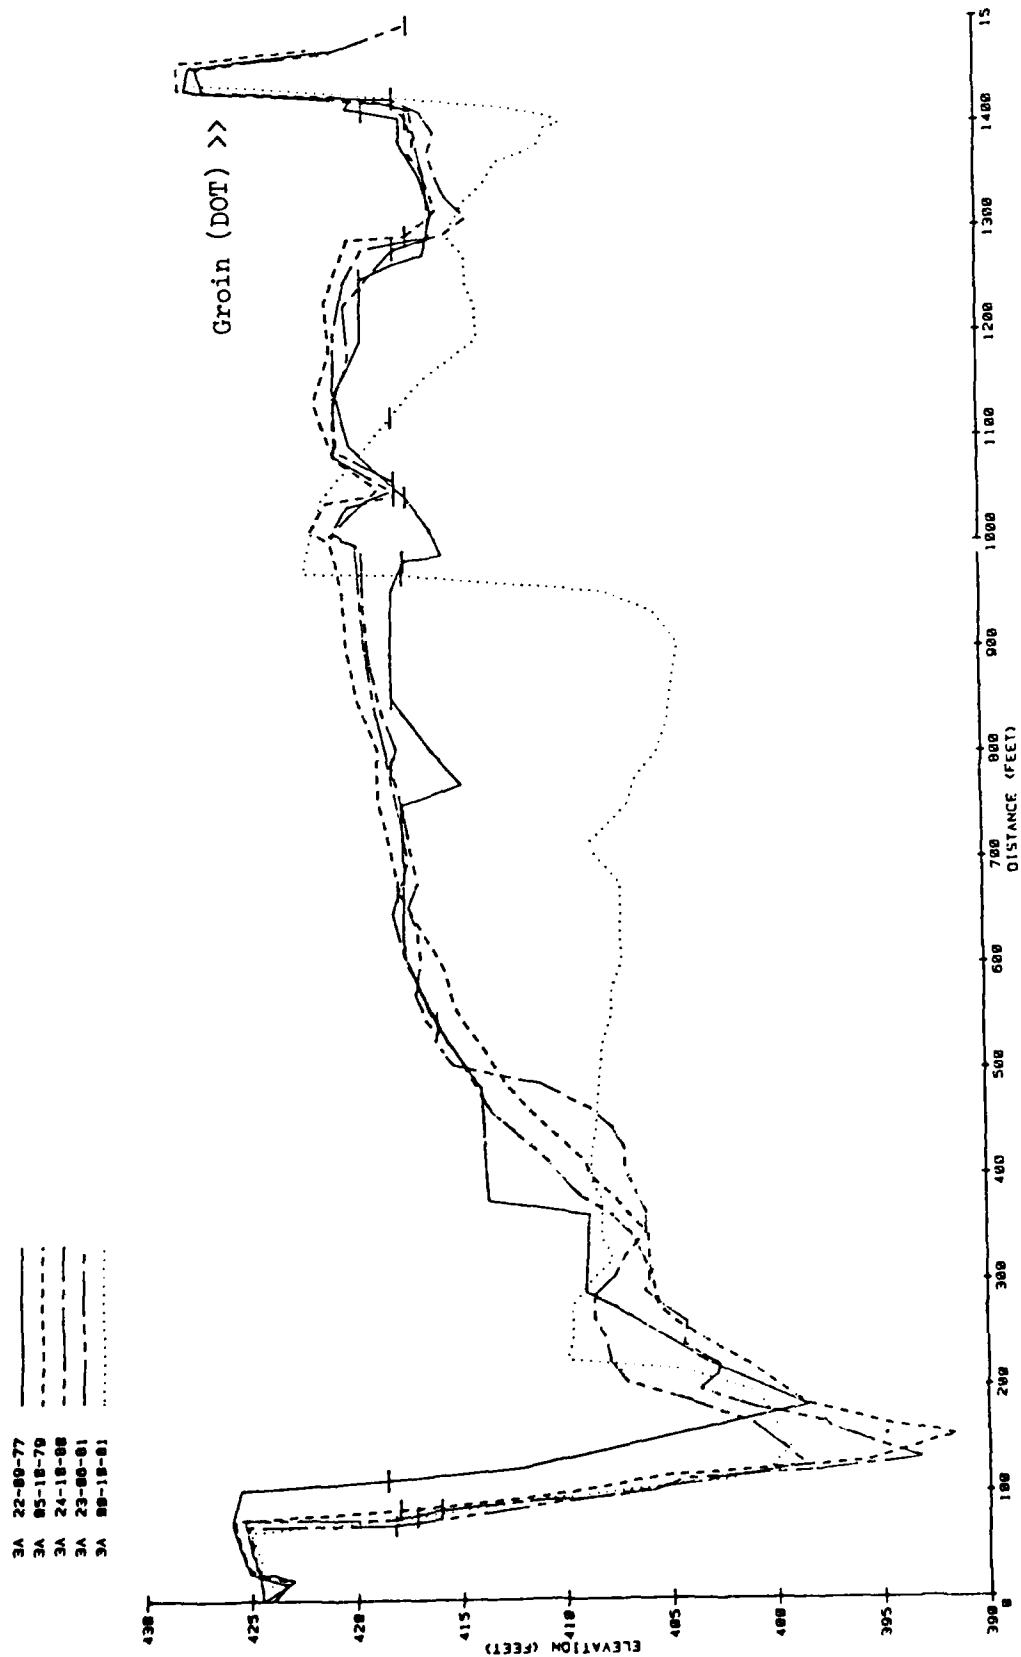
Figure 23. Tanana River cross section 3A, 1977-1981.

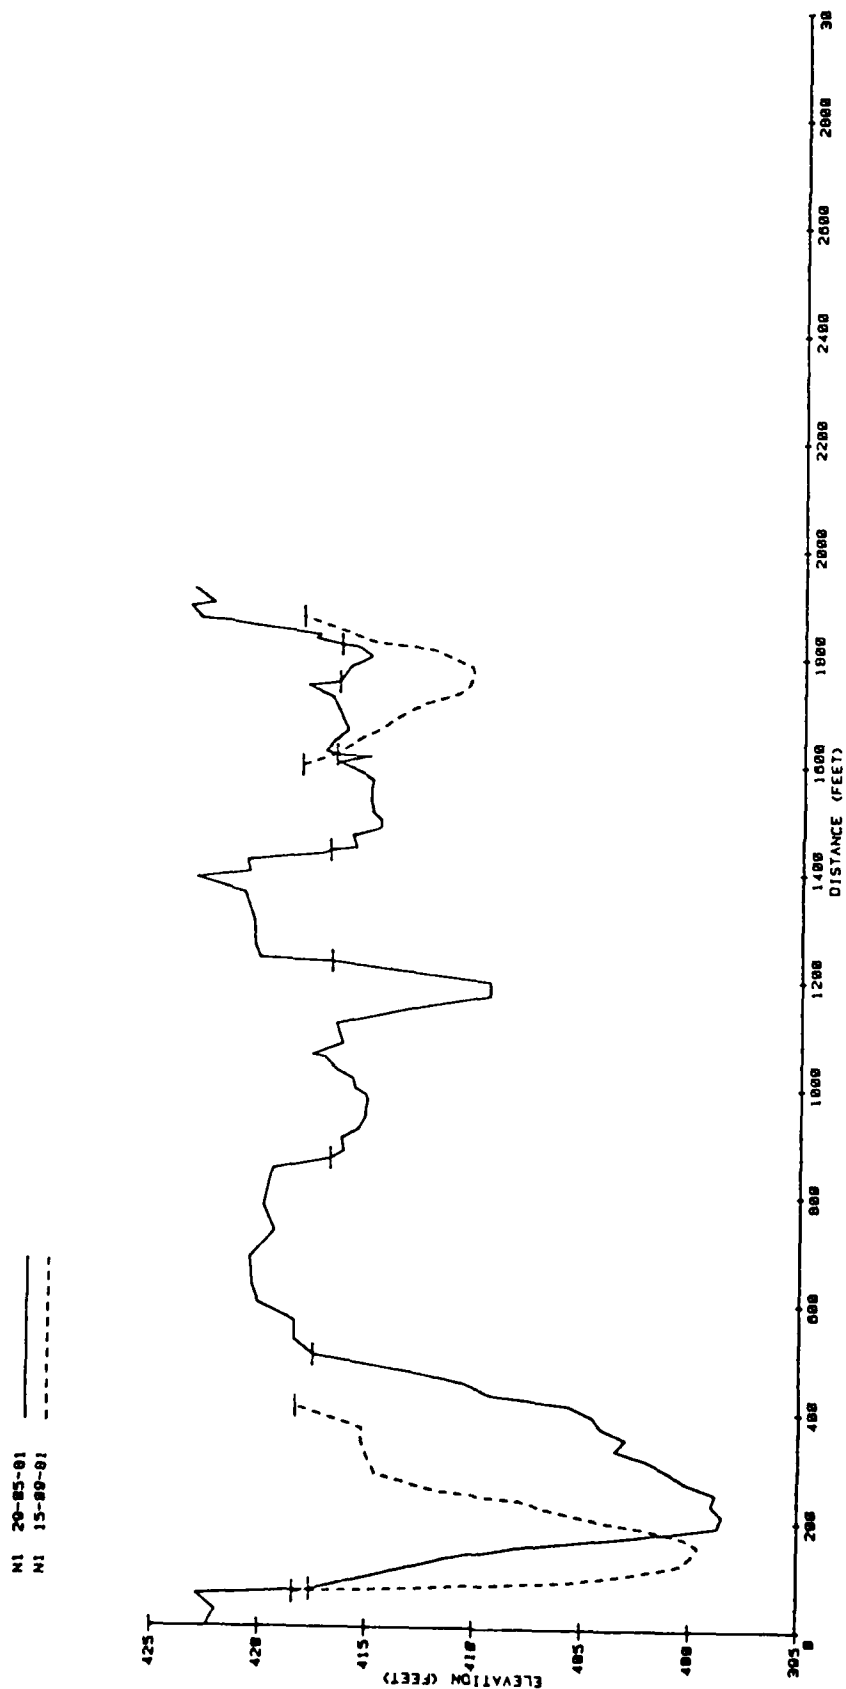
Figure 24. Tanana River cross-section N1, 1981.

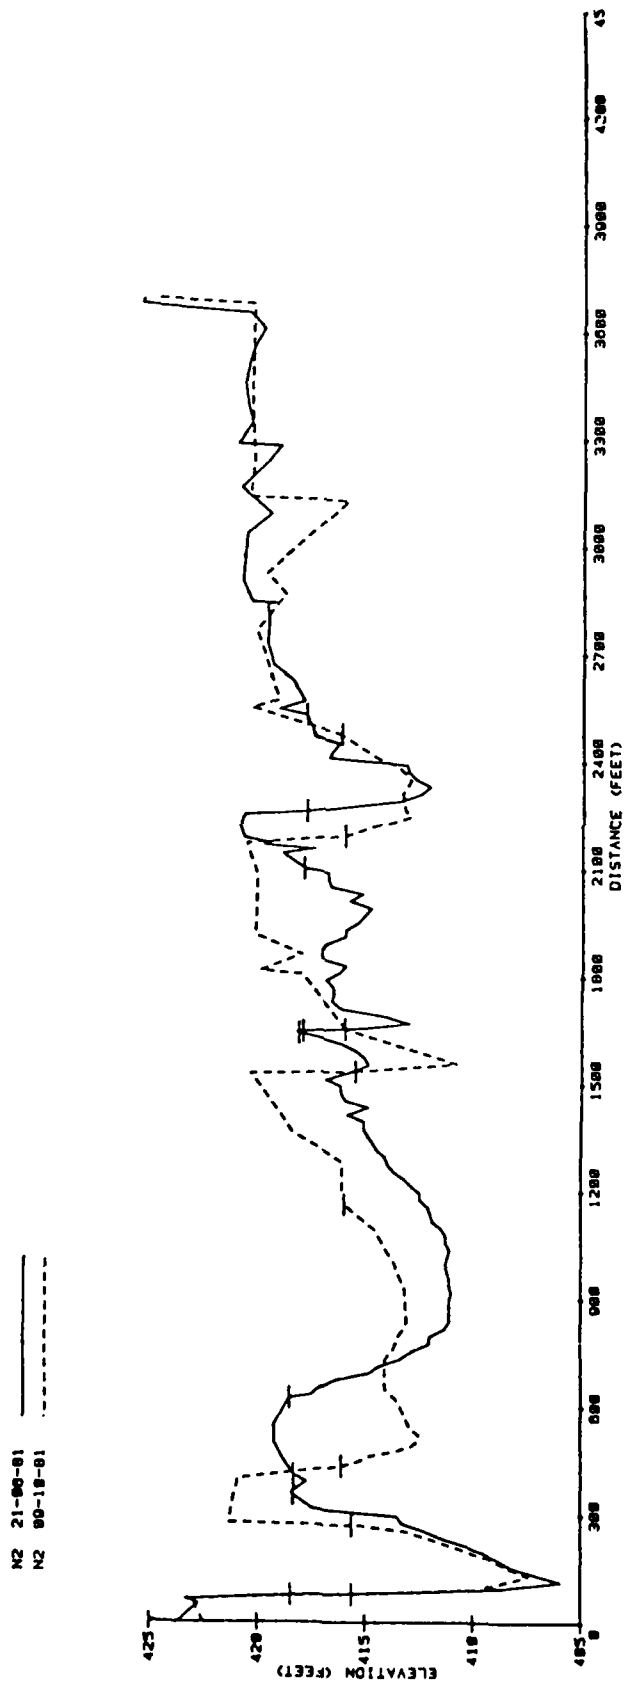
Figure 25. Tanana River cross section N2, 1981.

<u>Cross-section</u>	<u>Date</u>	<u>South Bank</u>	<u>North Bank</u>	<u>Channel</u>	<u>Remarks</u>
N2 (Fig 25)	21/06/81-09/10/81	stable	30 ft erosion	large areas of scour and deposition across entire floodplain	new cross-section established in 1981 at widest point on large meander bend
				enlargement of north secondary channel	
2A (Fig 26)	22/09/77-05/10/79	stable	stable	large bar located near the center of the floodplain scoured up to 10 ft across a 250 ft width	bar erosion is typical of cross-sections during this time period (5A, 4A, 3A) but thalweg deposition not found at upstream locations
				deposition at the main channel (thalweg) of up to 9 ft	
	05/10/79-24/10/80	20 ft erosion	stable	additional deposition in the main channel rebuilding of mid floodplain bar	
				channel on north side of floodplain enlarged to twice its previous size	
	24/10/80-25/05/81	missing	stable	minor changes across floodplain and right channel	main channel survey missing changes possibly due to ice scour and break-up affects

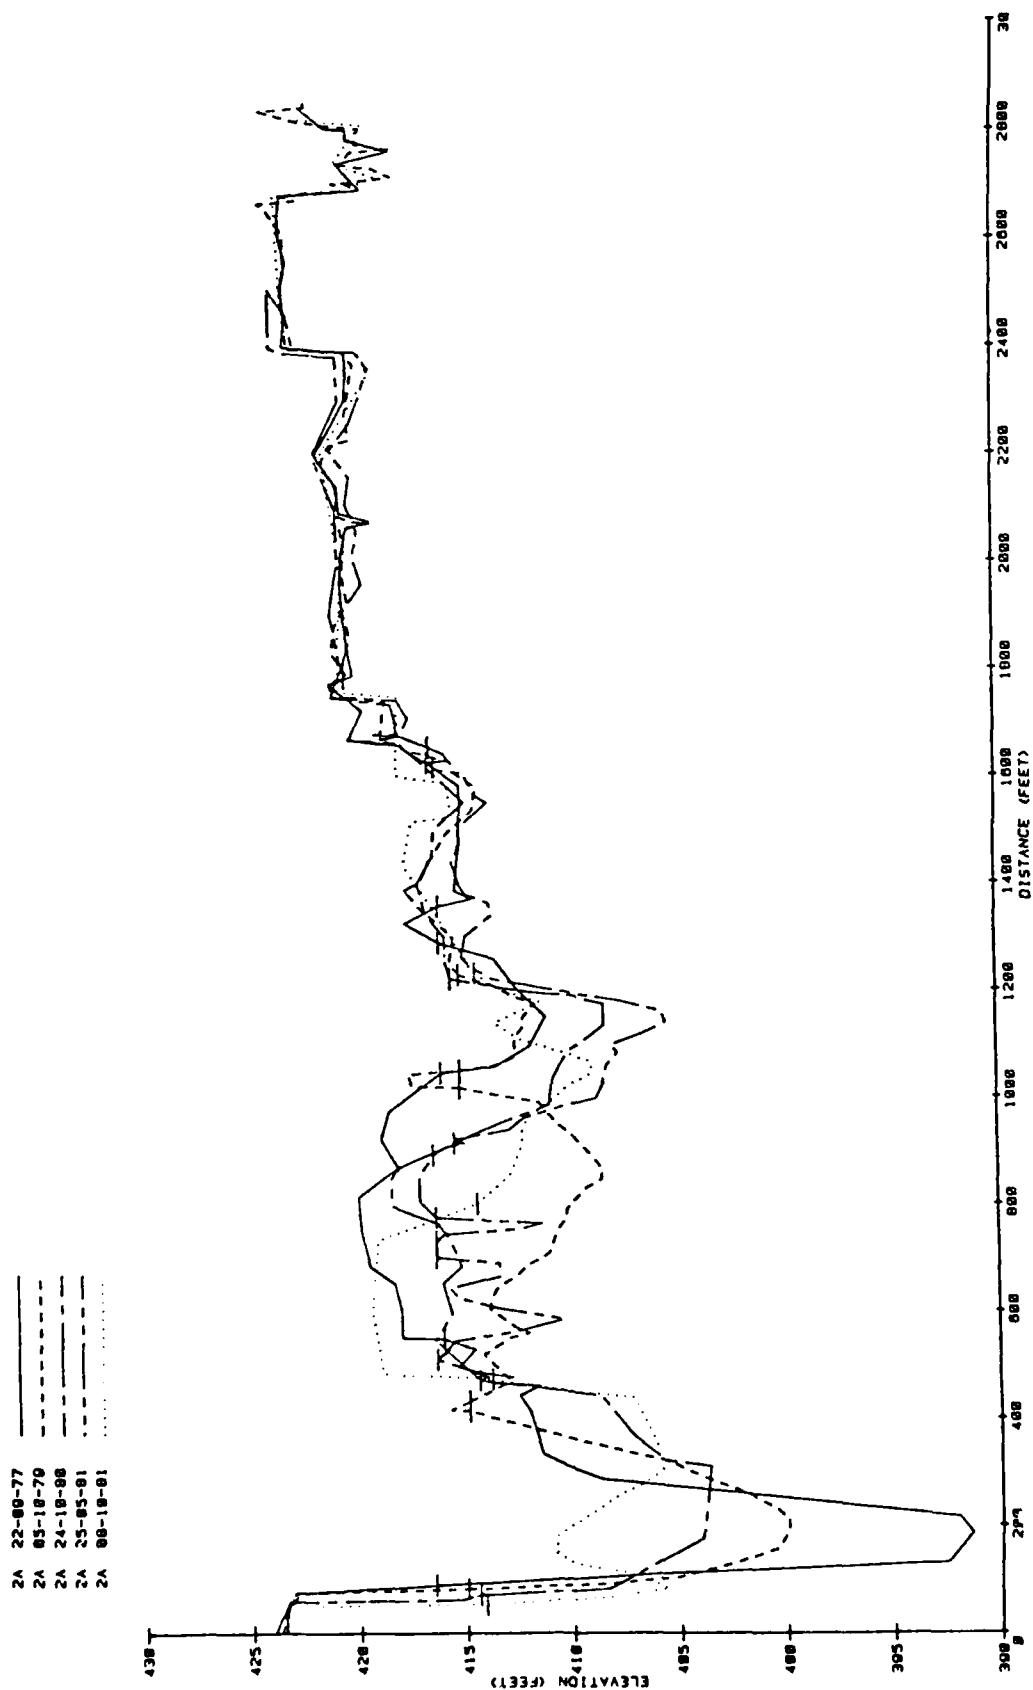
Figure 26. Tanana River cross section 2A, 1977-1981.

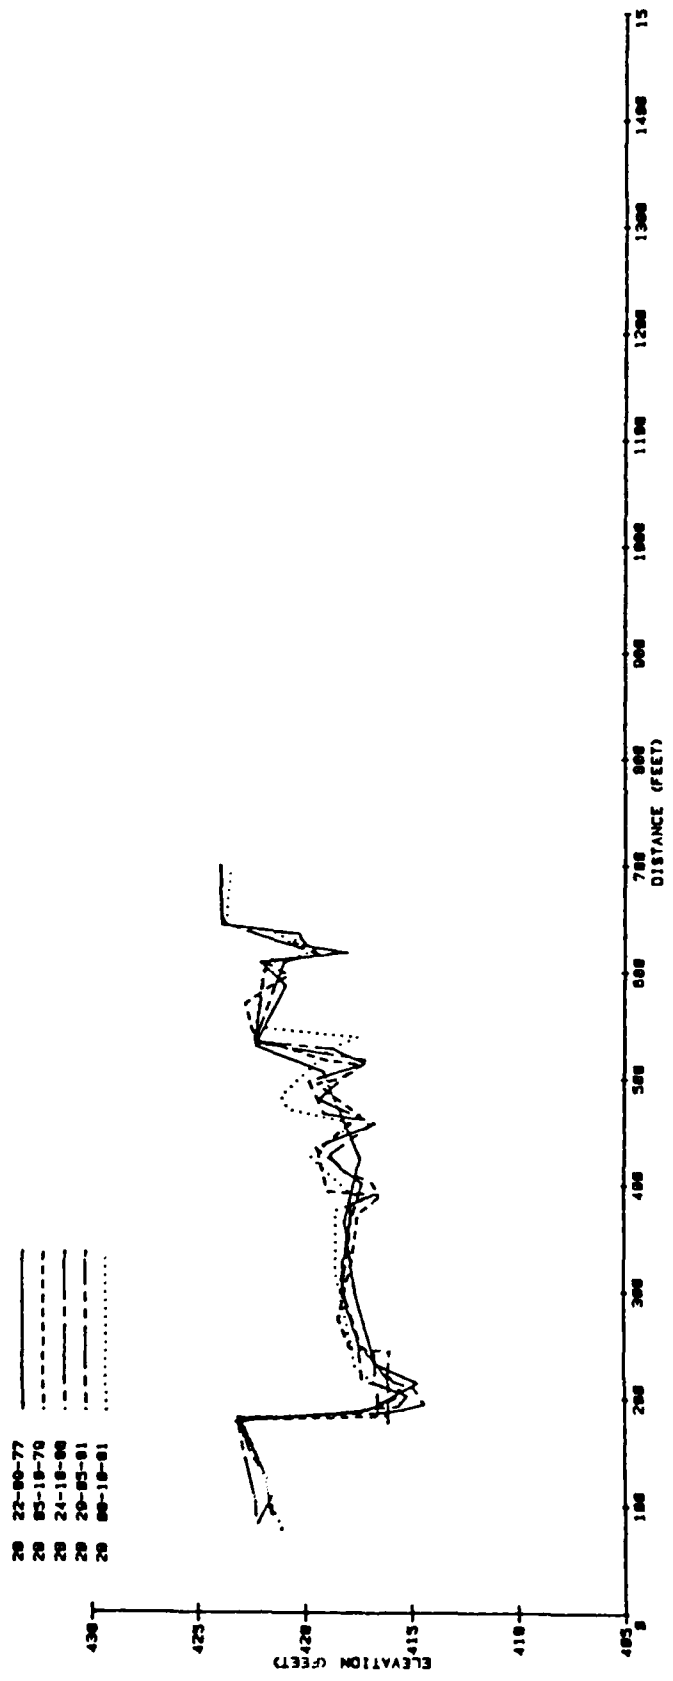
Figure 27. Tanana River cross section 2B, 1977-1981.
